THE MURALS OF VAT BO PAGODA IN SIEM REAP STATE OF PRESERVATION – FIRST RESULTS

Hans Leisen & Esther von Plehwe-Leisen *
Johannes Kroner, Lim Kwon-Wong, Alexandra Schenker & Svantje Winter **
German Apsara Conservation Project (GACP)

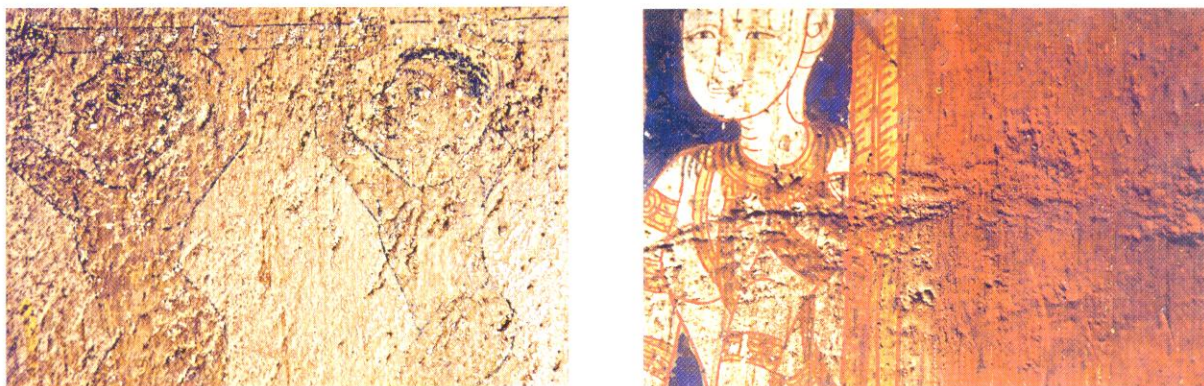
The walls of the vihear are made from brick covered by two layers of plaster. Most probably this is a lime plaster. The plaster surface is not smooth. It shows small furrows and cavities probably caused by the smoothing process. The application of the plaster started at the higher parts of the walls, as can be seen at the two overlapping lines ("pontata") (figure 3).

Figure 3: Furrows and cavities in the plaster (left), and joint of overlapping plaster ("pontata") (right)

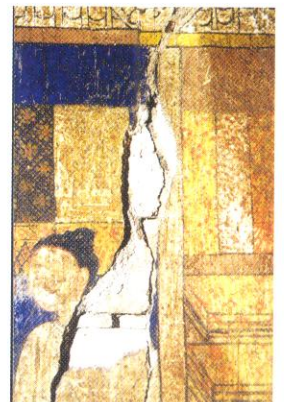
The most serious problem is caused by detachment of large areas, sometimes extending from cracks (figure 5). Detachments occur mostly between the mortar and the brickwork. The two mortar layers, on the other hand, still adhere well to each other. Around 30 % of the painted area shows signs of detachment, but most of these parts are still stable. Two large detached parts measuring up to 60 cm² each are missing. Detachment appears more frequently close to new mortar layers that have been applied at the top and the bottom of the murals.

Figure 5: Detachment connected to a crack

- Estimation of active static movements
- Pointing and injection of detached areas
- Closing of cracks
- Consolidation of the flaking paint layer
- Removal or reduction of splashes
- Cleaning/removing of varnish if possible without risk for the murals
- Removal of iron parts
- Removal of cement
- Straightening of the ends of the wall painting with a neutral retouche

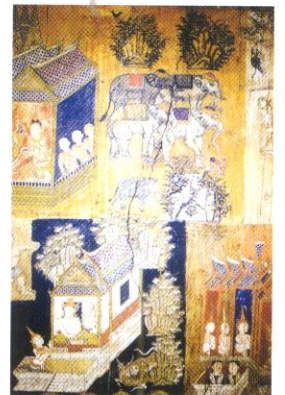
All four walls show static cracks differing in length (figure 6), width and depth, some also extending from top to bottom. The bigger cracks measure a few centimeters deep and tend to be open; smaller displacements are visible rather through closer observation of the painting. Detached areas are often connected to cracks; mortar is sometimes lost at contact points. Remains of insect nests can be seen inside the cracks on the eastern and western walls. Some cracks have been repaired in former times. Micro cracks not of static origin also exist, but obviously do not cause major damage.

Figure 6: Cracks caused by static tension

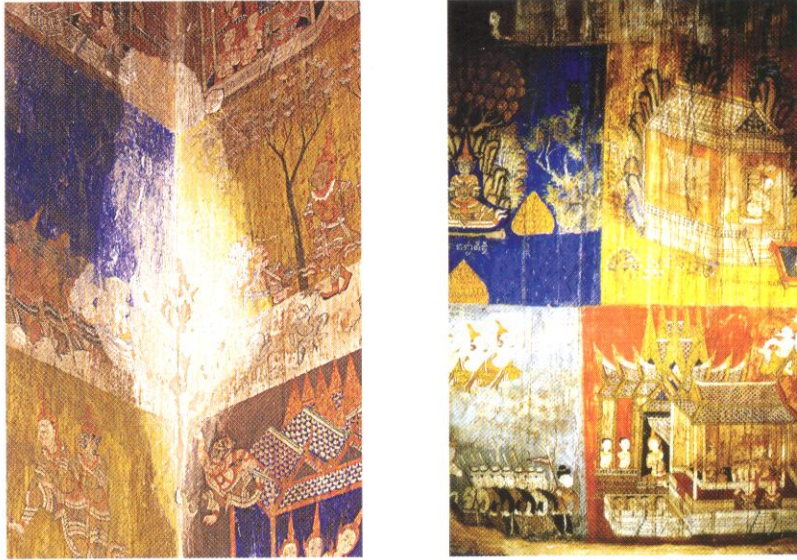
Water intrusion caused by open or leaking roofs is a prominent damage phenomenon. In "secco" painting technique pigments are not very tightly bound to the underground and tend to powder. Water run-off stripes are commonly seen where the pigments are thinned (figure 7). The dark background colors are

Figure 7: Water infiltration with signs of water run off and animal deposits

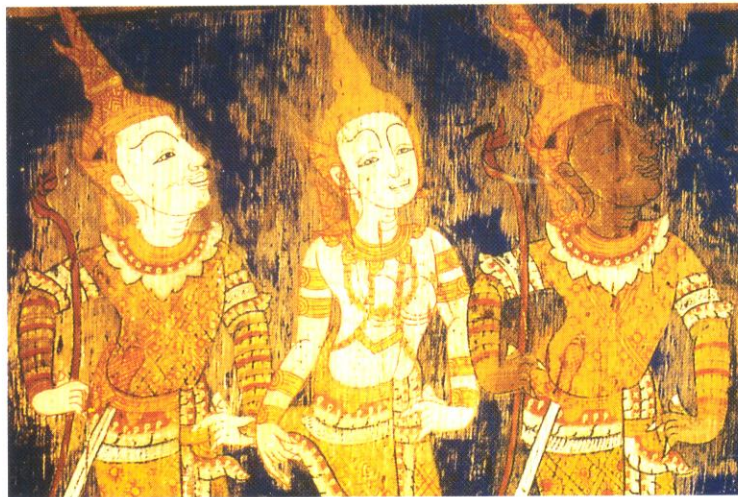
most affected by thinning processes not necessarily bound to water infiltration and causing irregular aspects (figure 8). As pigments and binder could not yet be investigated, the reasons behind this damage remain unclear. Paint layers in general remain in fact in quite good condition. Isolated flaking zones and missing parts can also be observed. Scratches due to simple carelessness and affecting the paint layer are ubiquitous.

Figure 8: Thinned blue paint layer

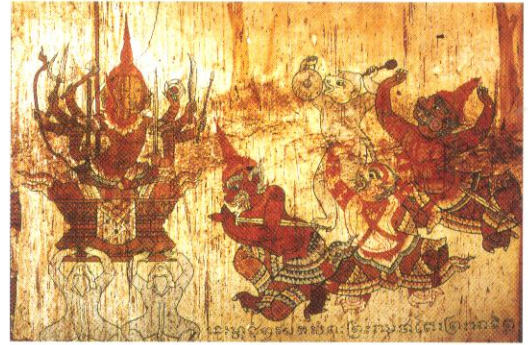
appears to have been quite careless during renovation activities. Splashes of paint, mortar, cement and other materials are found all over the paintings (figure 9) and sometimes even disturb the overall impression. Some of this material has come off over the years, taking along with it the underlying paint layer. Electrical installations such as cables and switches have also been fixed to the wall, damaging painting and mortar. The removal of insect nests, that often adhere very strongly to the wall surface, has left deep scratches in the painting and underlying mortar. Hooks, around which new mortar is visible, have been inserted next to the doors. With careless handling these hooks have caused detachment.

Figure 9: Splashes of paint and mortar from former repair work

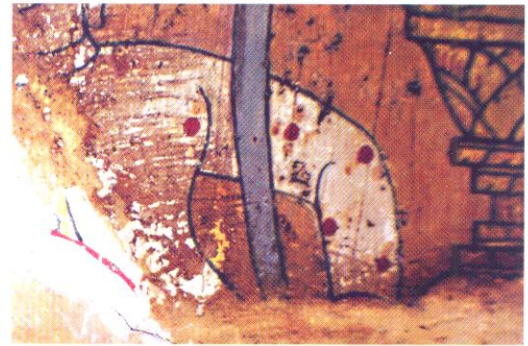
Figure 10: Coating on the paintings; the red and yellow lines on the left show original bright colors

The whole wall painting is quite obviously coated with a glossy varnish, which darkened and disguises the originally much brighter polychromy, as can be seen in small "windows" where the varnish is missing (figure 10).

In some parts the coating has fallen off, taking along with it the underlying paint layer. The varnish was applied as a thick layer using a brush of around 7 centimeters. The brush stroke is still visible. The coating covers all overpainting, new mortar areas and splashes and is obviously of quite recent manufacture, perhaps connected to a restoration project accomplished around 1940.

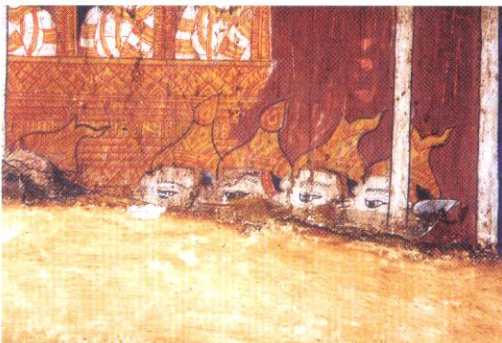
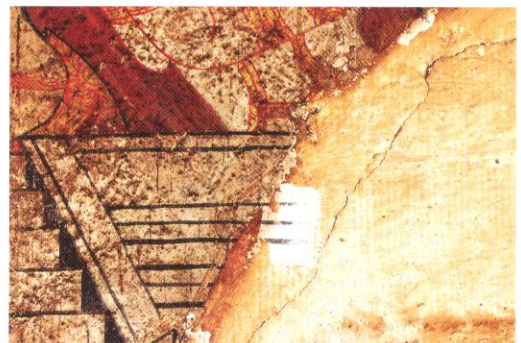
Renovation has often not been carried out in a professional manner. Additionally, unadapted materials have been employed. In the upper and the lower marginal zones of the murals we see large areas of new plaster and overpaintings (figure 11). In these areas the original paintings are missing. The overpaintings extend into the original painting with colors that differ considerably. Some parts in the middle of the painting have also been repaired with new plaster containing wooden dowels or nails.

Figure 11: Plaster from former repair work overlapping the paintings (left) and uncovered painting under plaster layers (right)
