THE MURALS OF VAT BO PAGODA IN SIEM REAP STATE OF PRESERVATION – FIRST RESULTS

Hans Leisen & Esther von Plehwe-Leisen *
Johannes Kroner, Lim Kwon-Wong, Alexandra Schenker & Svantje Winter **
German Apsara Conservation Project (GACP)

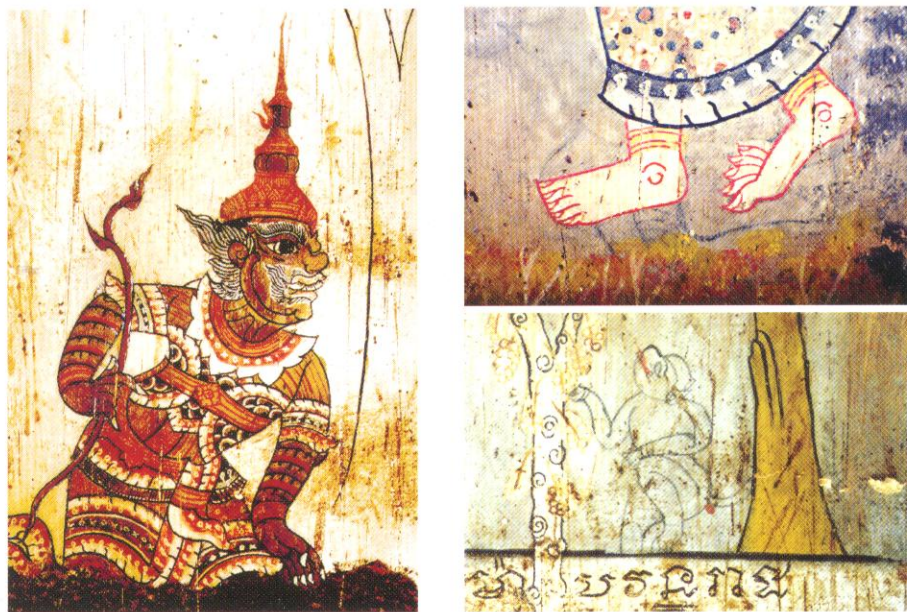
figure 4: Fine drawings in black lines contour light background colors (left). Change of design visible in underlying sketches in black lines (right).
